BA-188

Bellefield  
North side of Western Run  
Rd. east of Cuba Rd.  
Not Accessible  
Circa 1820

## INVENTORY FORM FOR STATE HISTORIC SITES SURVEY

BA-188  
Bellefield (Tashiding)  
1900 Western Run Road, Cockeysville  
Hereford Quadrangle

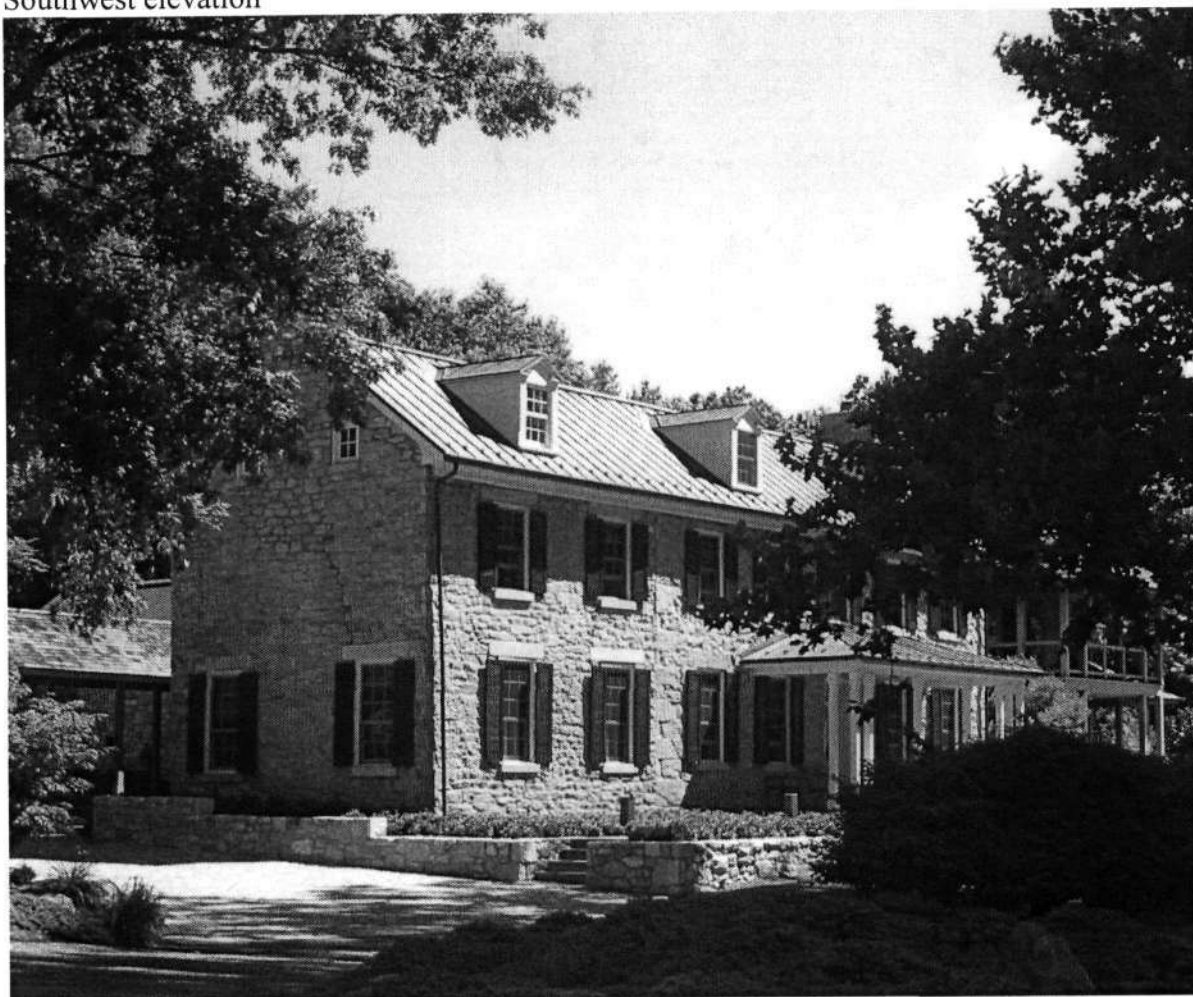
BA-188  
Bellefields (Tashiding)  
1900 Western Run Road, Cockeysville  
Jennifer K. Cosham, 12 July 2007  
Southwest elevation
